## Technical Report No. 7

**U.S. Army Corps of Engineers**  
St. Louis District

1. AGENCY USE ONLY (Leave blank)		2. REPORT DATE 1996		3. REPORT TYPE AND DATES COVERED Final Report
4. TITLE AND SUBTITLE  An Archaeological Curation-Needs Assessment of Cape Canaveral Air Force Station, Florida			5. FUNDING NUMBERS

# **AN ARCHAEOLOGICAL CURATION-NEEDS ASSESSMENT OF CAPE CANAVERAL AIR FORCE STATION, FLORIDA**

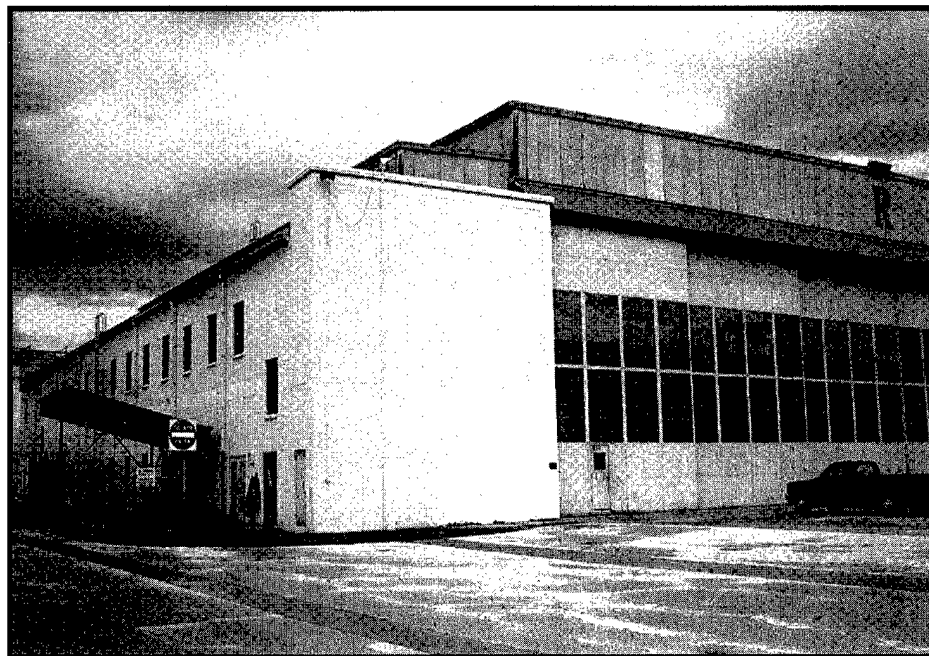
Figure 1.  
Southwestern view  
of Hangar R, Cape  
Canaveral Air Force  
Station.

The Environmental Engineers Office is located in Hangar R (Figure 1) on Cape Canaveral Air Force Station. The three-story, concrete-and-metal hangar was constructed in 1956. Its original use was as an airplane hangar, but currently it is being used for office space and for the base utilities shop. Approximately 1,020 ft<sup>2</sup> serves as the Environmental Engineers Office and as storage space for archaeological records and artifacts.

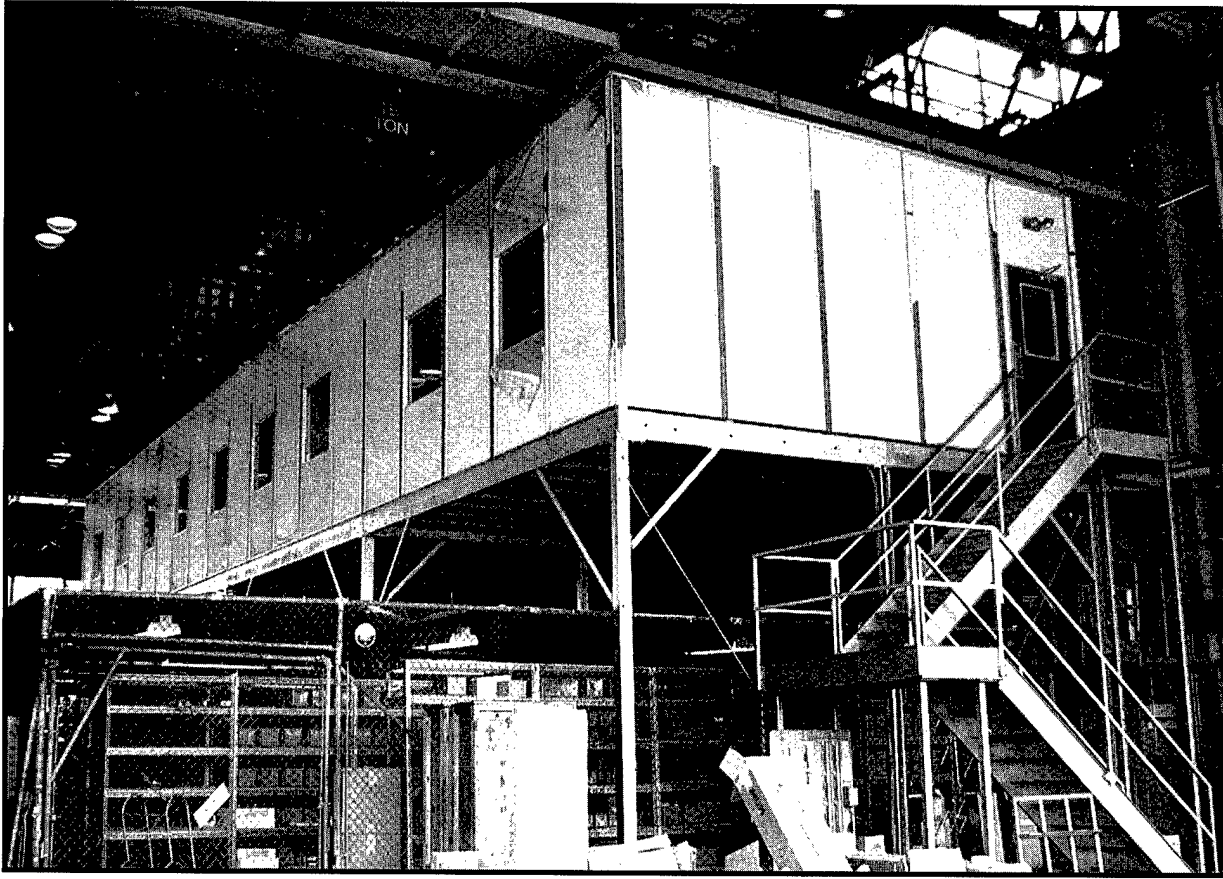
Figure 2. Structure in Hanger R that houses the Environmental Engineers Office.

Hangar R was renovated five years ago to include the Environmental Engineers Office, a trailer-type structure with a steel frame, fiberglass panel walls, and a carpeted plywood floor. The office, which is elevated from the main level by a prefabricated steel mezzanine, is accessible from the floor of the hangar by steel staircases at the north and south ends and to the east by a steel gangway from the permanent offices located on the side of the hangar (Figure 2). Sixteen windows, which do not open, show no signs of water or air leaks. The suspended acoustical-tile ceiling has no water damage.

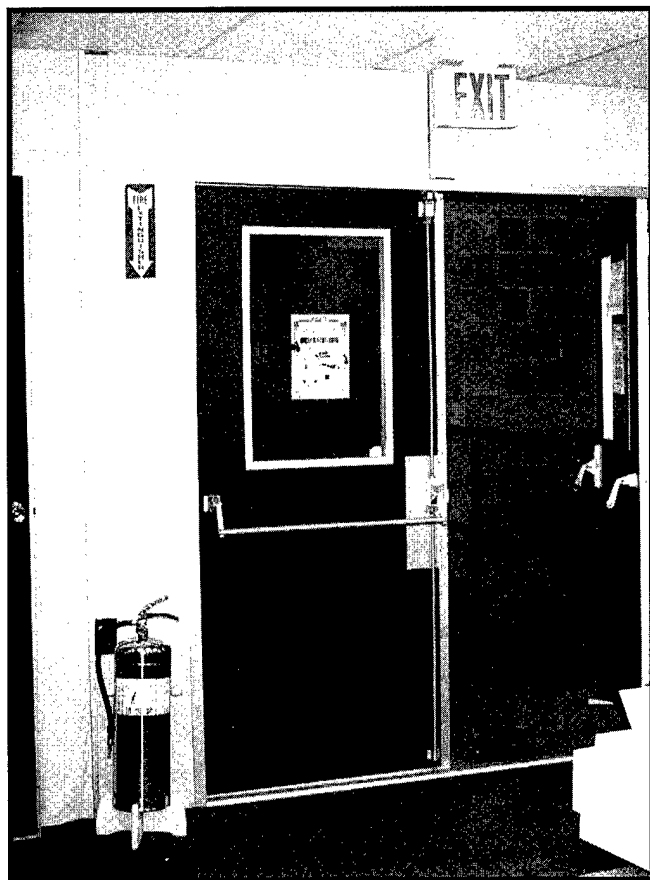
Figure 3. Exterior double doors on the east side of the Environmental Engineers Office.

A base pass is required to enter Cape Canaveral, and access to the Environmental Engineers Office is controlled. The exterior doors to the office are metal and are secured with a key lock (Figure 3). Personnel at Cape Canaveral indicated that unauthorized access to the building has not been observed.

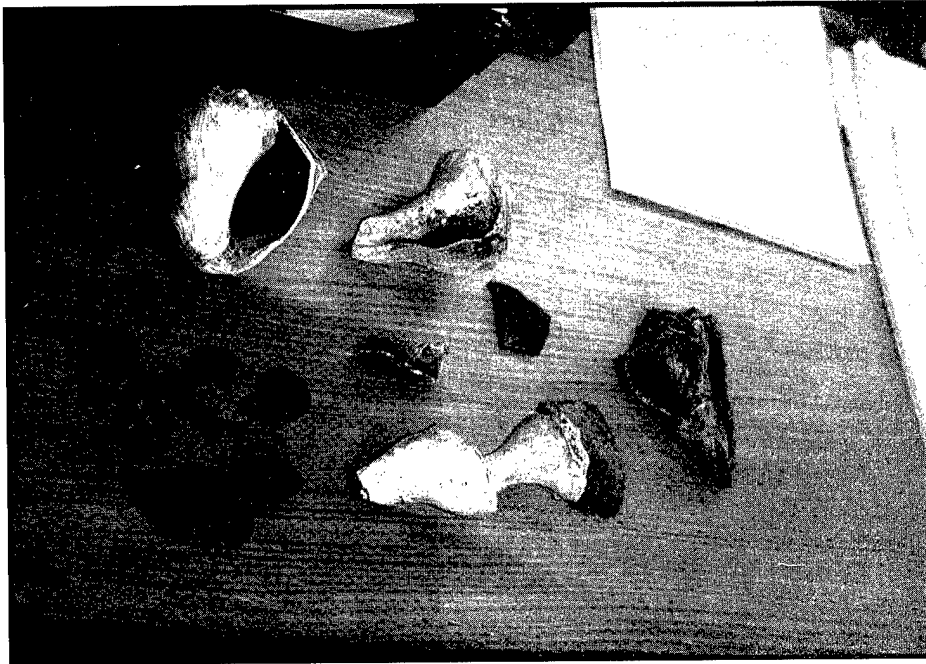
Figure 4. An example of the artifacts that are stored in the Environmental Engineers Office.

Some archaeological materials that have been recovered from the surface of Cape Canaveral property are stored in Don George's office. Most of the large artifacts, such as historical-period metal and glass, are stored loose under a desk. Small items—i.e., shell fragments, lithic material, and ceramics (Figure 4)—are kept in two-mil, nonarchival, plastic bags in the desk drawers.

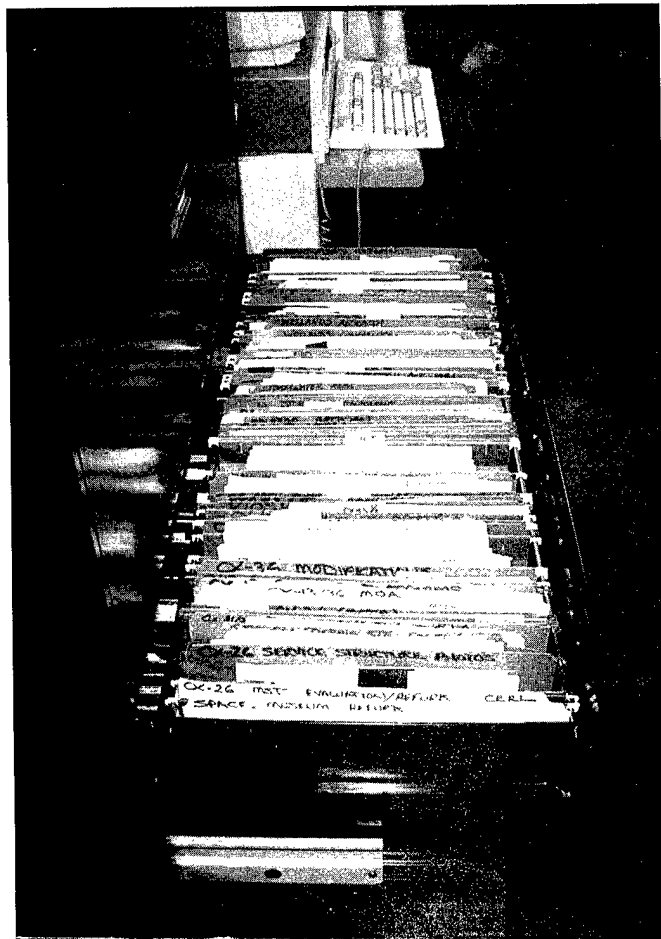
Figure 5. Cultural resources and archaeological records are stored in lateral filing cabinets in the Environmental Engineers Office.

Less than one linear foot of associated documentation is housed in six acidic file folders in a metal, lateral file cabinet in Don George's office (Figure 5). These records consist primarily of administrative files, background material, survey records, and excavation records. There were no photographic, audiovisual, or machine-readable records associated with the archaeological work performed on Cape Canaveral.

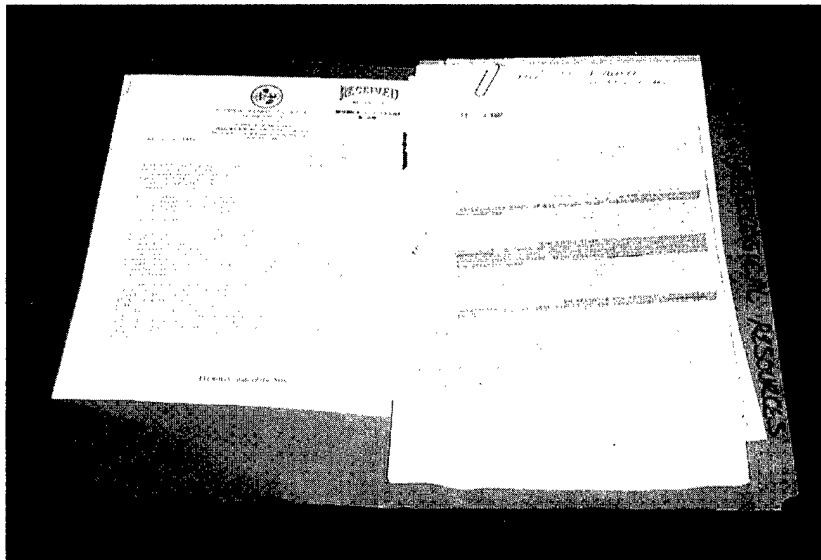
Figure 6. An example of the records that are stored in the Environmental Engineers Office.

Fifty percent (50%) of the paper records is administrative records—correspondence, contract information, and permits (Figure 6). One folder is entirely background material, primarily newspaper clippings about archaeological work done on the station. The last two folders have a small amount of excavation and survey records.

Folders are labeled directly in either pen or marker with a general description of the folder contents. Dates are not included in the label information. Background materials such as newspapers are beginning to deteriorate, and newspaper stock is discolored and brittle. Paper touching the newspaper also is discolored from the acidic newsprint. Throughout the files, there are contaminants such as staples and paper clips, and, in some cases, these are badly rusted and are destroying the paper. The collection is not arranged in any manner, and accession data are not available.

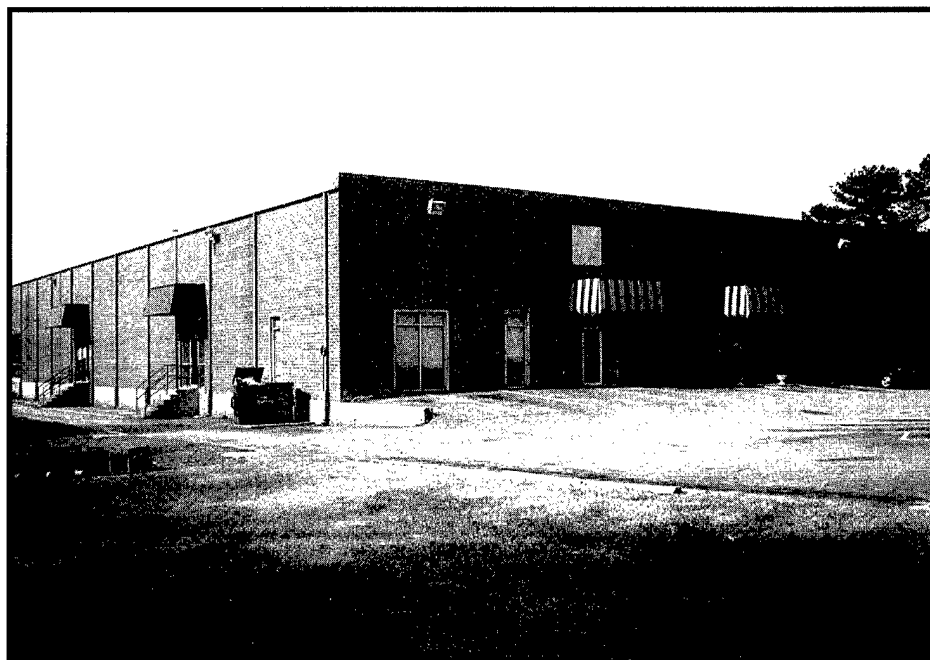
Figure 7. Exterior view of New South Associates.

Building construction consists of bricks on a concrete slab foundation (Figure 7). The roof is flat and sealed with tar and gravel. The foundation and roof are structurally solid. Electrical and plumbing systems were partially upgraded in 1988.

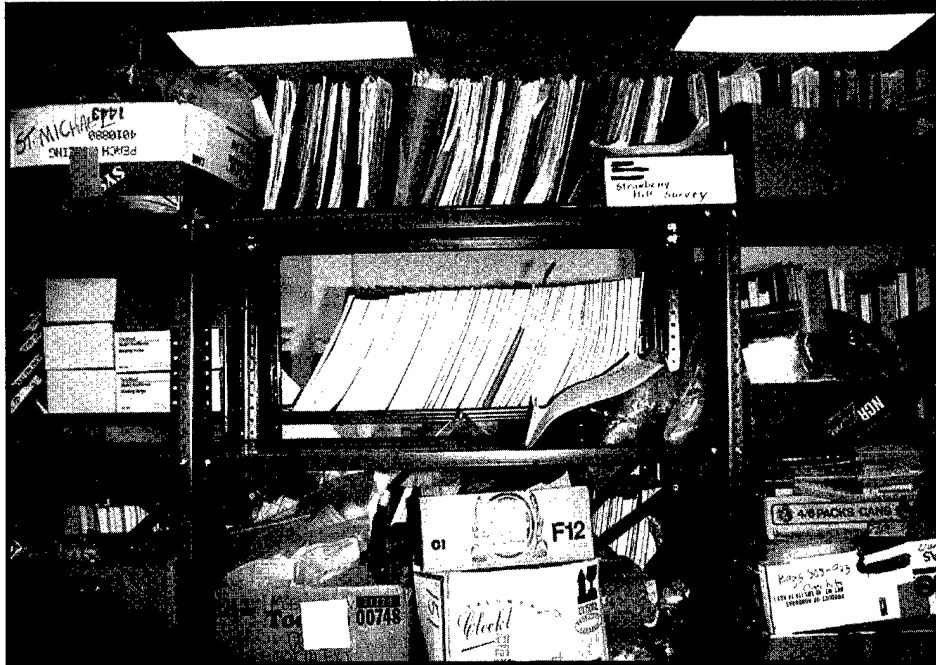
Figure 8. Cape Canaveral Air Force Station artifacts at New South Associates are stored on baked-enamel metal shelves.

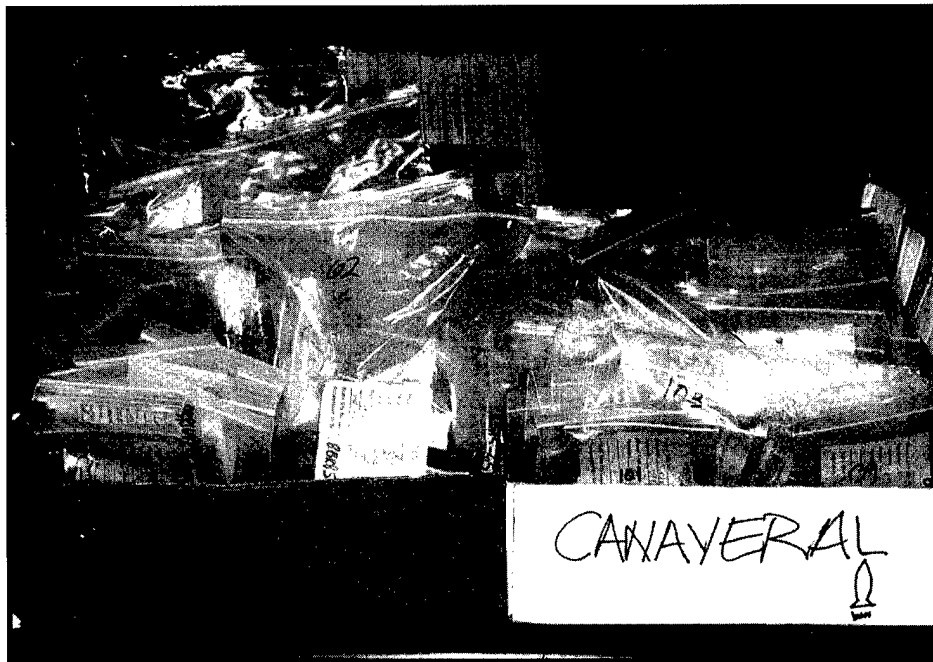
The Cape Canaveral collection currently is stored in seven various-sized acidic cardboard containers, six of which have no lids (Figure 9). One is secured with folding flaps.

Figure 9. Primary and secondary containers for Cape Canaveral artifacts at New South Associates.

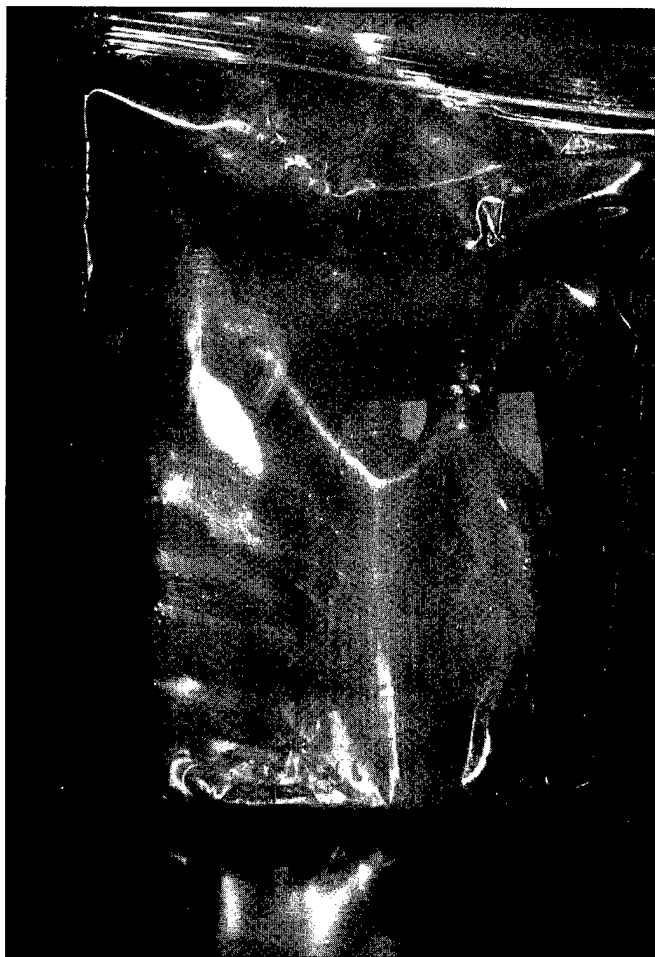
Figure 10. An example of a secondary container, with historic bottles from Cape Canaveral.

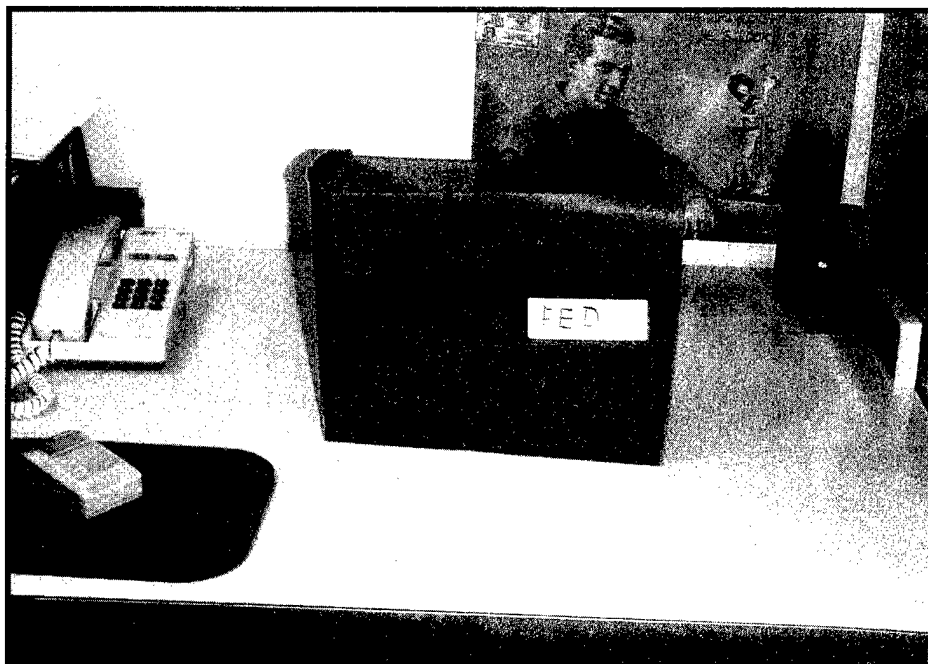
Figure 11. Expandable folder holding Richard Levy's excavation records.

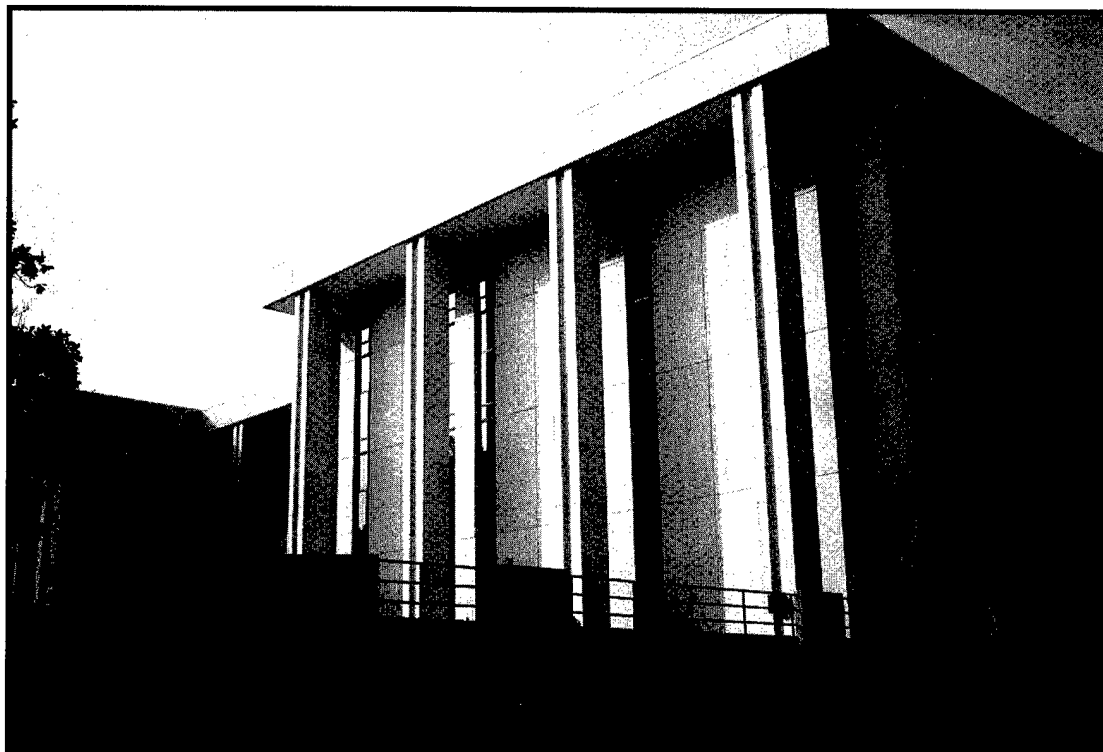
Constructed in 1975, the R. A. Gray Building (Figure 12) is structurally sound. Exterior walls and ceilings are concrete. Interior walls are constructed of cement blocks. The Gray Building houses the Florida Division of Historical Resources, the Bureau of Archaeological Research, the Florida State Archaeological Site Files, the State Library of Florida, the Museum of Florida History, and the Florida State Archives. The Bureau of Archaeological Research is administrated by the Florida Division of Historical Resources.

Figure 12. Exterior view of the R. A. Gray Building.

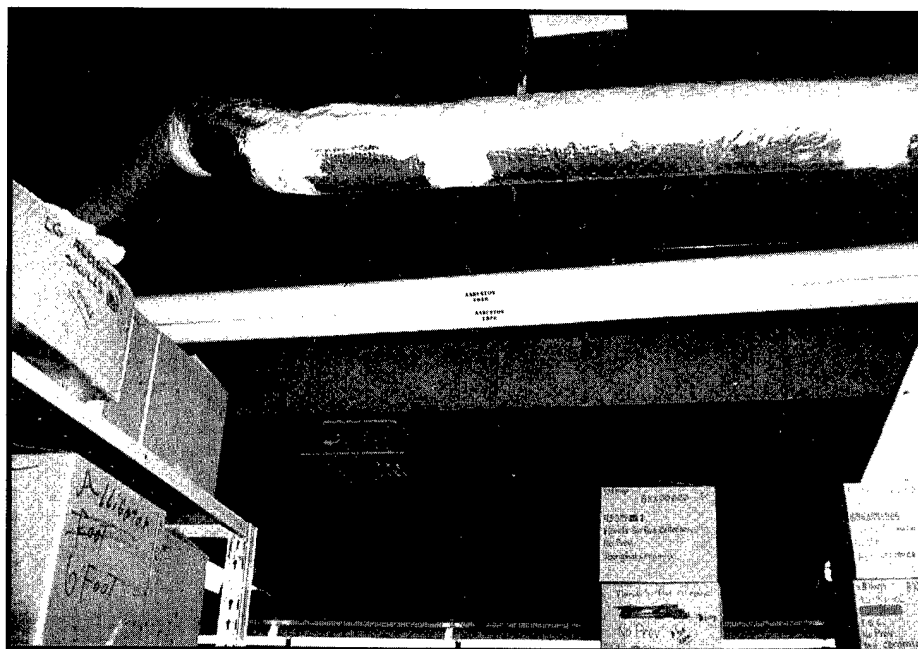
Figure 13. Pipes and ductwork in the collections storage area at the Florida Bureau of Archaeological Research.

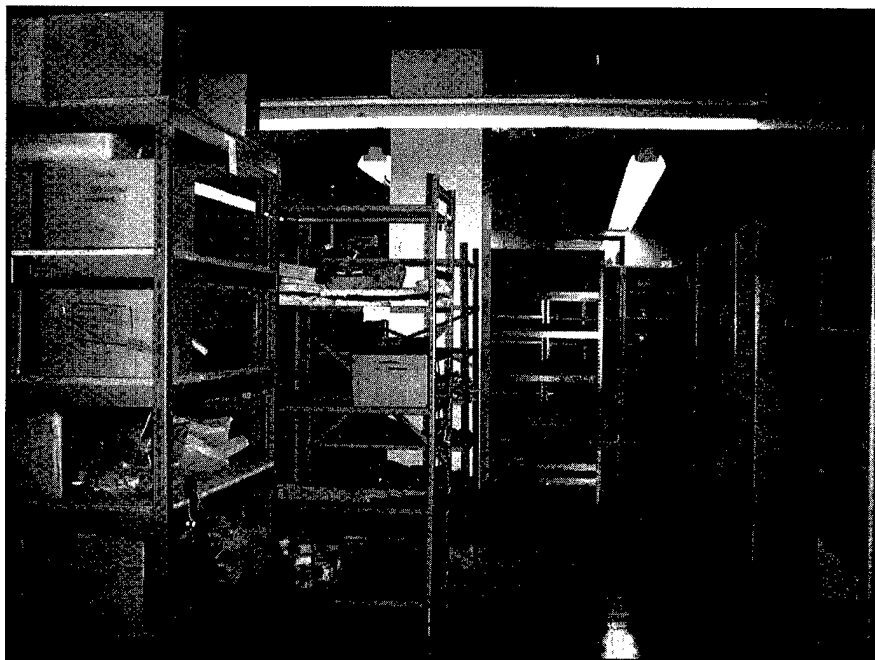
Figure 14. Primary containers are placed on painted-steel shelves in the collections storage area at the Florida Bureau of Archaeological Research.

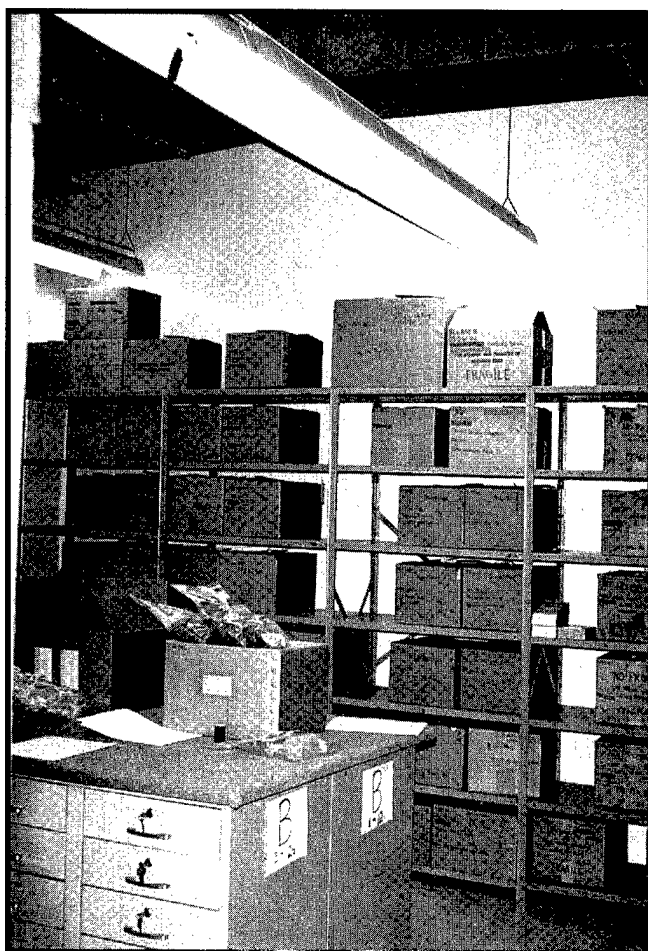
Archaeological materials from Cape Canaveral are currently stored on painted-steel shelves (Figures 14 and 15). Collections are arranged and stored by a trinomial accession numbering system. Collections are readily accessible, and no artifacts are systematically excluded from curation. The current storage space is adequate for collection storage.

Figure 15. Another view of the collections storage area at the Florida Bureau of Archaeological Research.

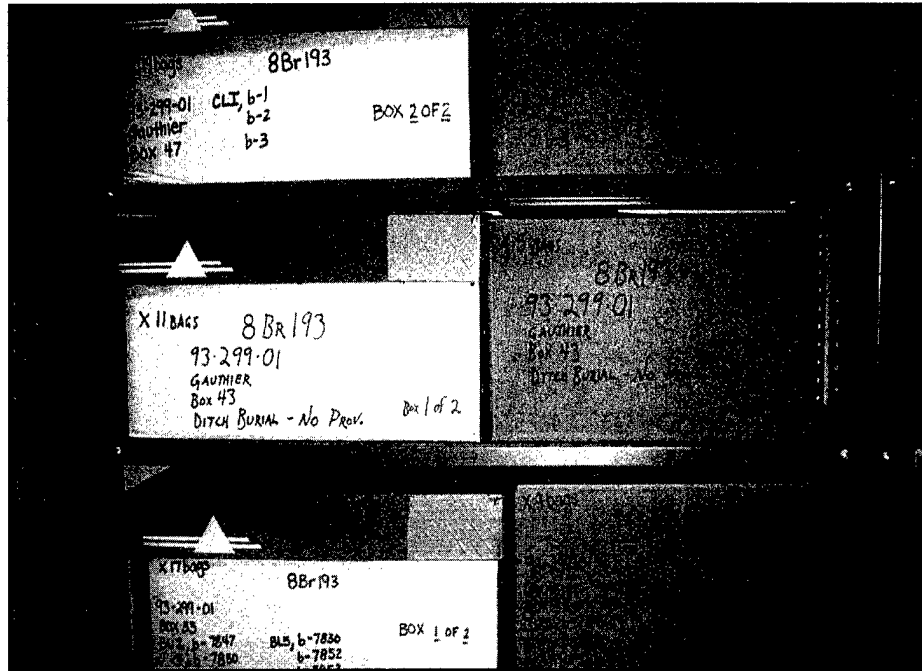
Figure 16. Acidic cardboard boxes are the primary containers for the Cape Canaveral artifacts.

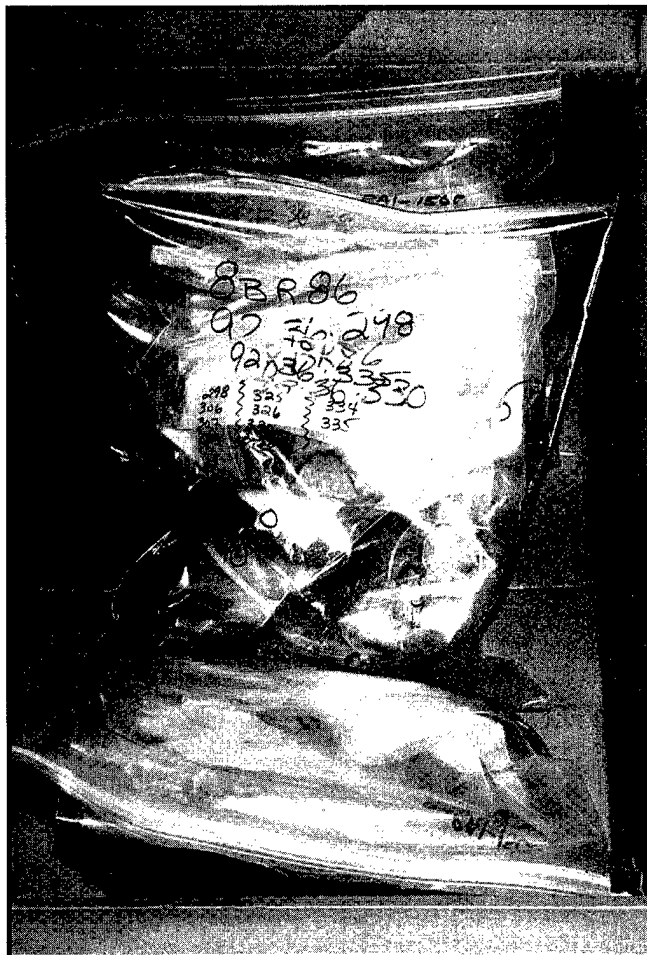
Secondary containers consist of two- and four-mil, plastic, zip-lock bags (Figures 17 and 18). Bags are labeled directly in marker with provenience data, including site number, site name, date, and/or excavator names or initials.

Figure 17. Interior view of one of the primary containers with Cape Canaveral artifacts. Note nested secondary containers within the cardboard box.

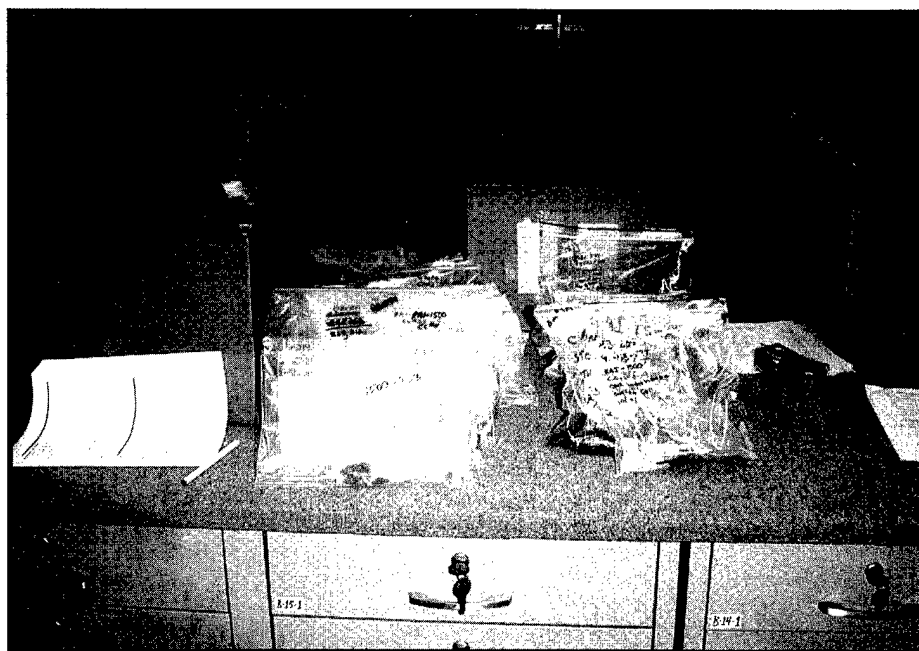
Figure 18. Nested zip-lock, plastic bags in secondary containers.

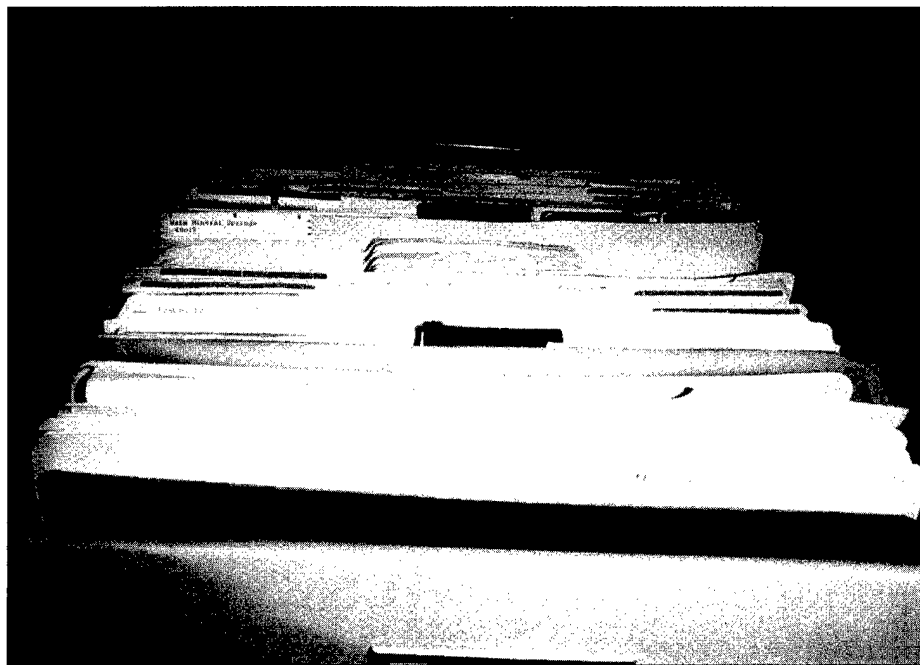
Figure 19. Legal-size, metal file cabinets house associated documentation at the Florida Bureau of Archaeological Research.

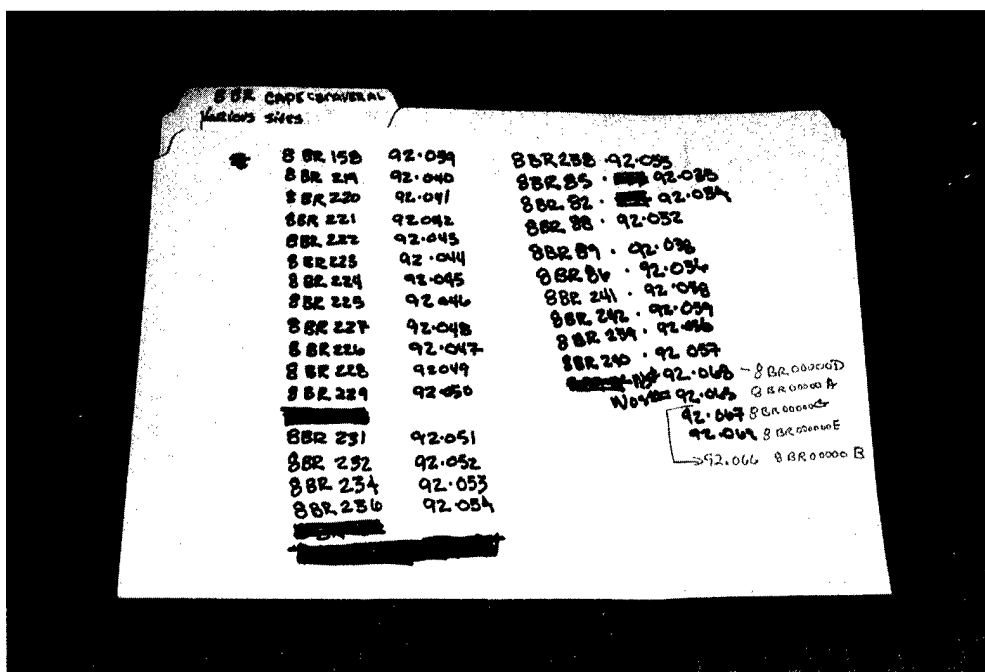
Figure 20. Nonarchival manila folders hold a number of the Cape Canaveral associated records.
